DEPARTMENT OF NATURAL RESOURCES  
DIVISION OF OIL, GAS AND MINING

RE: Site Inspection, Diamond K Gypsum, Diamond K Quarry, M/015/041, Emery County, Utah

Date of Inspection: May 30, 2003  
Time of Inspection: 8:00 to 10:00 a.m.  
Conditions: Mostly clear, 70's  
Participants: Karen Palmer and Clint Henrie (Diamond K) and Paul Baker (DOGM)

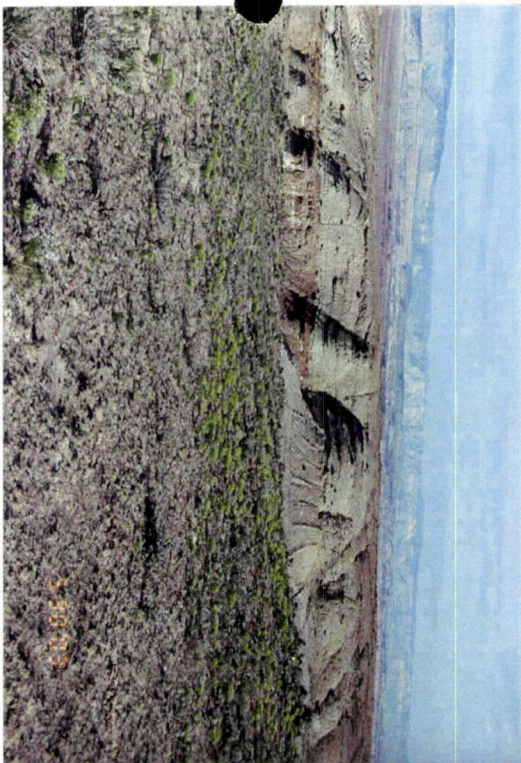
I took vegetation cover measurements on 35 quadrats scattered over the area proposed to be disturbed (Photo 1). Although I tried to cover the entire area and believe my measurements were as objective as I could make them, I do not believe they were placed in a valid scientific or statistical manner. I do feel, though, that they are adequate for establishing a revegetation success standard.

The dominant species encountered in order of cover values were Fremont pepperweed (*Lepidium montanum*), shadscale (*Atriplex confertifolia*), Gardner saltbush (*Atriplex cuneata* var. *gardneri*), Indian ricegrass (*Oryzopsis hymenoides*), and Green's rabbitbrush (*Chrysothamnus Greenei*). Total vegetative cover was 6.07 percent. Cover from cryptogams was estimated as 21.2 percent, and cover from litter was estimated as 11.5 percent.

Photo 1. Undisturbed area where the operator intends to mine.

I was surprised at how little vegetation cover there was in the undisturbed area. The lack of vegetation cover could partly be a function of the drought, but for now, the revegetation success standard will be 4.2 percent. Cover in undisturbed areas should be checked periodically to see if remains constant or if it changes when there is more precipitation.

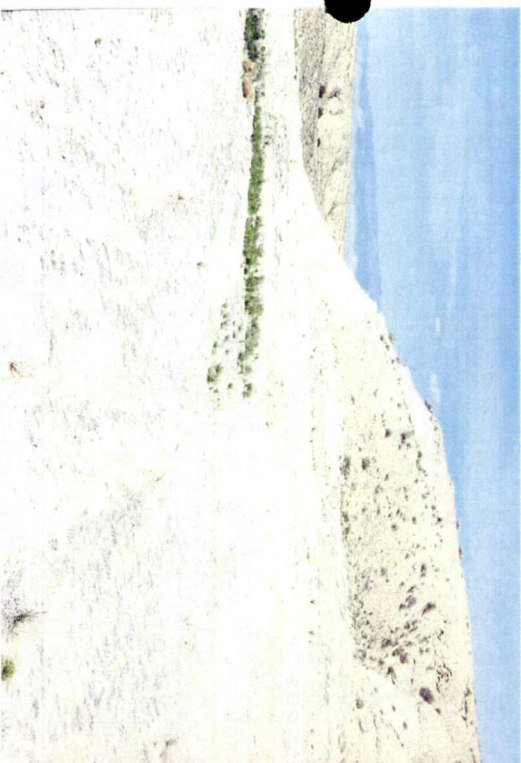
The amount of cover in the reclaimed area is similar to what we found last February. Desirable species found in this area include smooth brome, orchardgrass, Indian ricegrass, and crested wheatgrass, and they are mostly concentrated in one swale (Photo 2). Photo 3 also shows part of the reclaimed area. Although there were numerous weed skeletons from previous years, we found almost no living weeds.

Photo 2. Part of the previously reclaimed area. The vegetation in the left center portion of this photo is in a swale.

The operator has expressed a willingness to reseed those areas that were previously graded and seeded, but the Division and the operator need to consider alternate revegetation methods. There is what appears to be a test plot at the nearby Eagle Canyon Mine where gypsum was placed on the surface (Photo 4). This area has very good vegetation growth. There are quite a few rocks on the surface in this location, and this may also have positively influenced the amount of vegetation cover.

It might be beneficial for the operator to apply a layer of waste gypsum over the topsoil. This assumes the waste gypsum contains coarse fragments that would help increase water infiltration. Even just applying rocks to the surface, not necessarily gypsum, would probably be beneficial.

The Division, the operator, and the BLM should develop a detailed plan for how reclamation is to be accomplished in the fall. This plan should include a revised seed mix and surface preparation plans, including roughening techniques and application of gypsum or other materials.

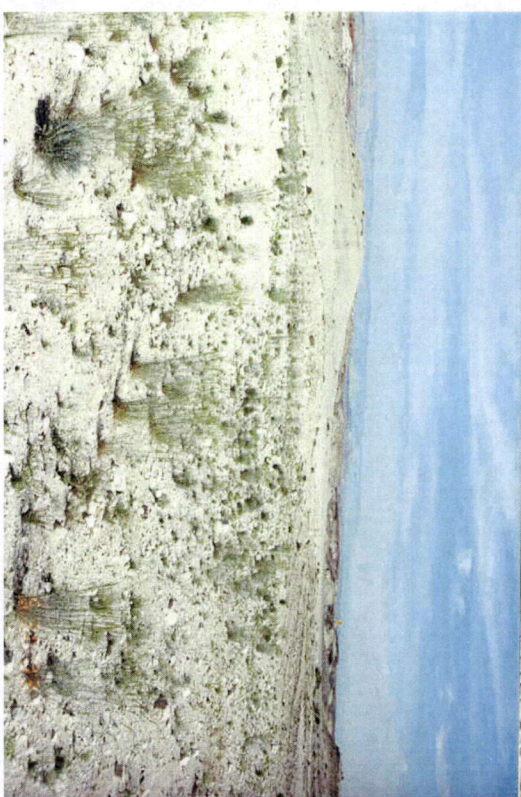
Photo 4. This is the area at the Eagle Canyon Mine where there has been some coarse gypsum placed on the surface.
